μ RS Update

Installation

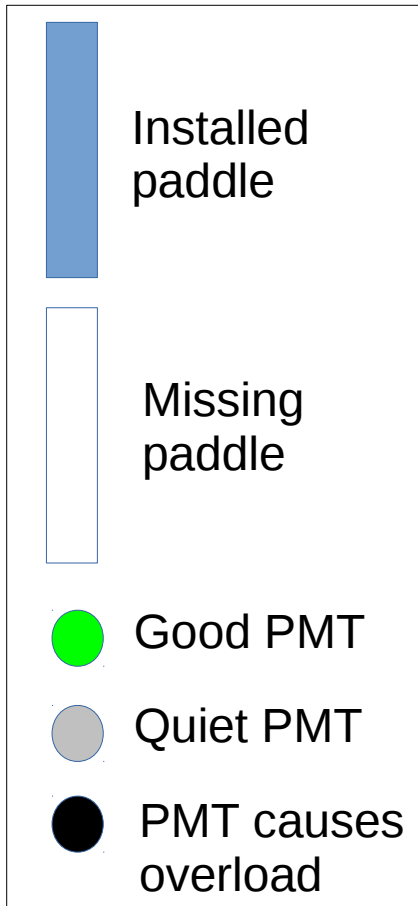
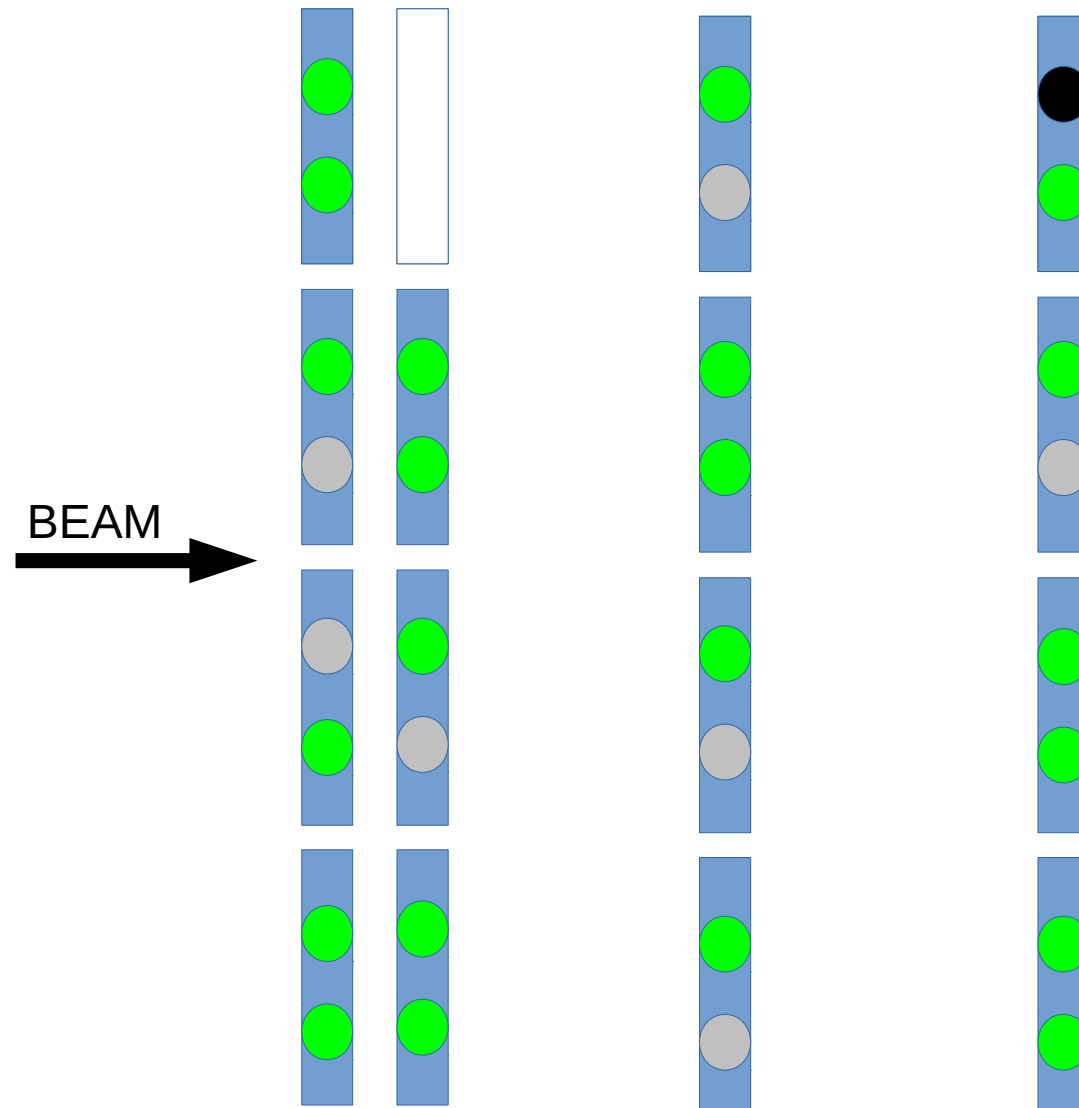
State of the Detector

- We still have 7 PMTs that provide no pulses when powered.
- Unsure of the cause. Leading hypothesis is problems with the readout cables analogous to the HV problems.
- Left in place for now. No pairs of quiet PMTs \Rightarrow every paddle has **at least 1** functioning PMT.
- Take efficiency hit for now, investigate at next open access opportunity.

- PMT that causes power supply overload (needle twitches uncontrollably) is left unpowered for now (other PMT on that paddle is fine).
- One paddle is still not installed.
 - This is the one with the bad bracket + unpolished surface.
 - Assembled it as best we could and ran tests; could not achieve more than ~50% efficiency for double/triple coincidence tests.

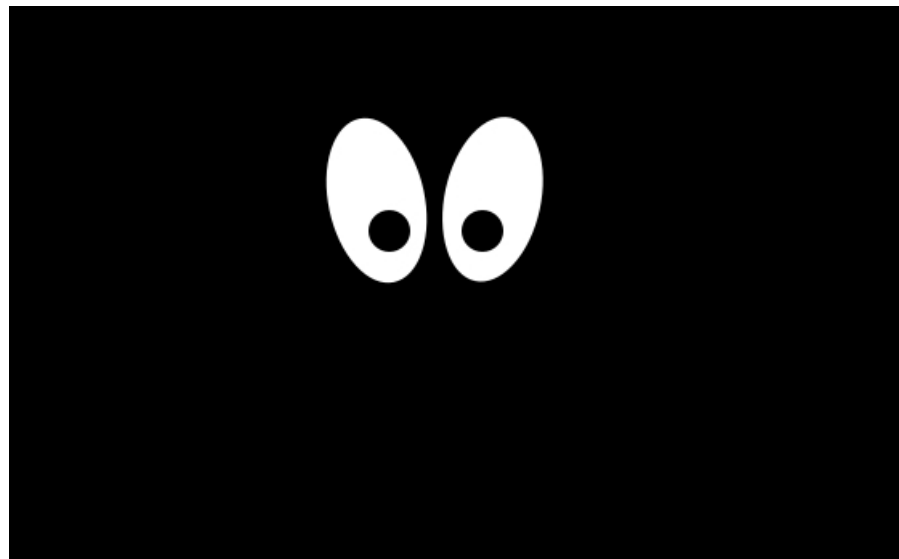
Light-tighting

- Each PMT jacketed in special light-tight paper.
- Each paddle wrapped in same paper (including PMT bracket \Rightarrow PMTs double-wrapped).
 - Weak point where the wires leave.
- Put a plastic blanket over the stack.
